HUMPBACK BRIDGE

Unique design has helped Humpback Bridge span generations.

Humpback Bridge
ALLEGHANY CO. VIRGINIA

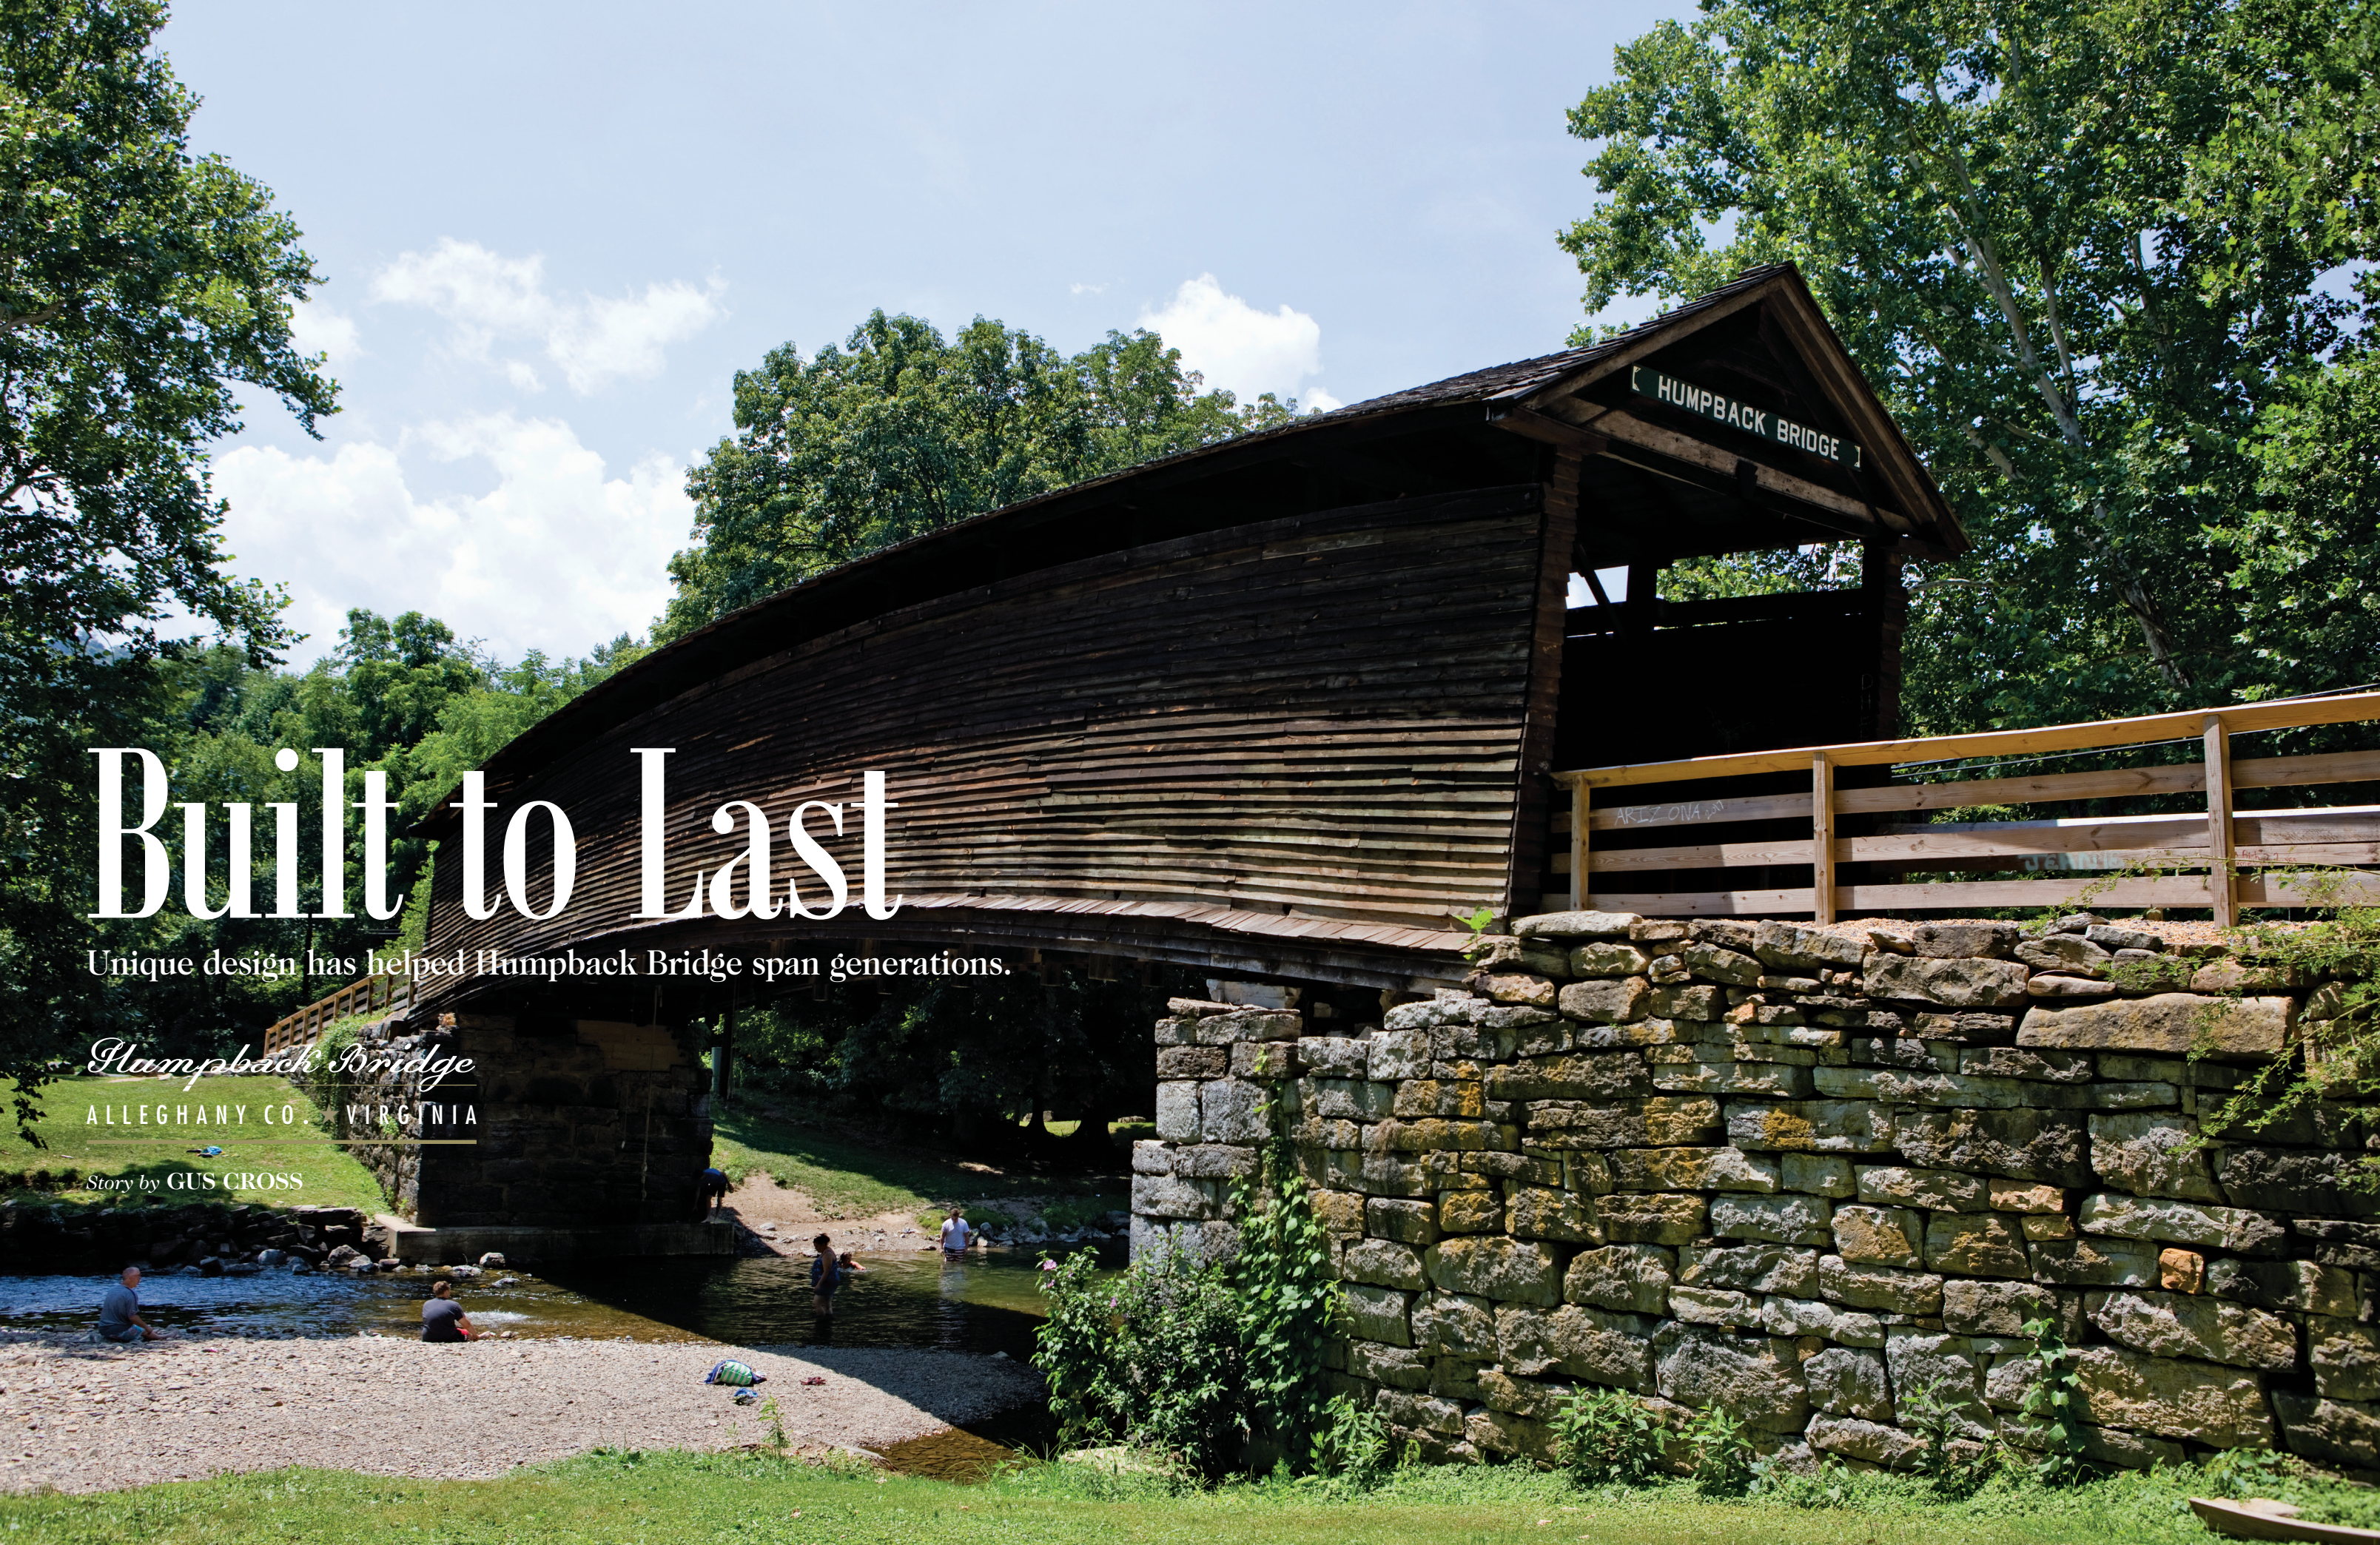
FULLY ARCHED

Humpback Bridge is unique among covered bridges in that the entire span is arched over Dunlap Creek. That makes the center about 4 feet higher than the ends, allowing it to avoid floods that might have otherwise damaged or destroyed it.

In 1792, revered bridge builder Timothy Palmer designed the trussed arch, an arch bridge that featured two trusses built onto the arch. The arch did most of the work while the truss reinforced it. His design likely inspired the design of the Humpback Bridge; however, its entire truss system is arched, taking most of the force itself instead of displacing it onto the abutments as a true arch bridge would.

The arched shape causes the center of the bridge to be just over 4 feet higher than at the abutments, elevating it above potential flood waters. The combination of the stronger truss and elevated center helped the bridge survive devastating floods, such as the one Alleghany and Botetourt counties saw in 2016.
